Morro Bay National Estuary Program's  
Implementation Effectiveness Program  
For the Morro Bay Watershed

**2007 Eelgrass Monitoring Report**

May 23, 2008

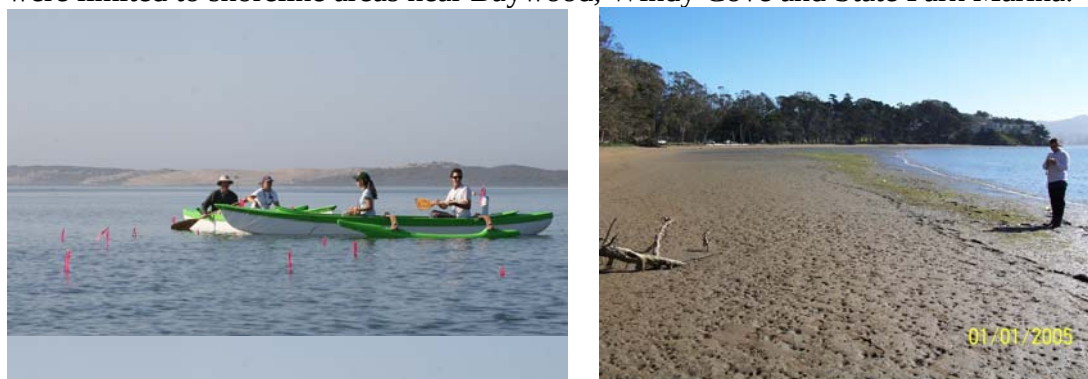
*Left:* Ground truthing during calm conditions with flagging. *Right:* Ground truthing shoreline areas by foot during extreme low tides.

A limited number of field surveys were conducted on foot at extreme low tides. These surveys were limited to shoreline areas near Baywood, Windy Cove and State Park Marina.

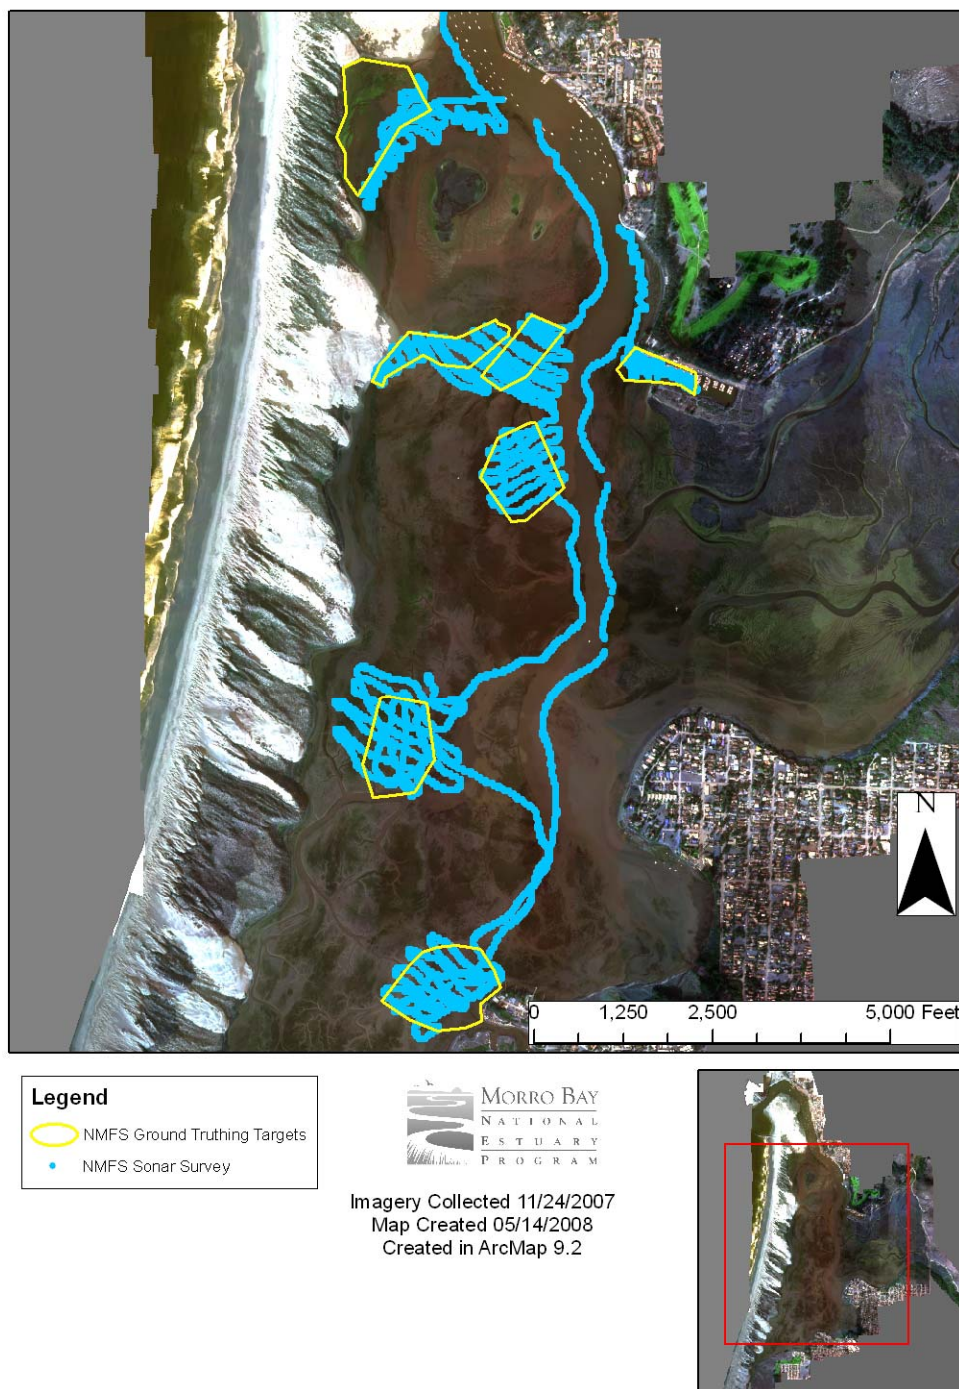
**Figure 8.** NMFS Single Beam SONAR Surveying November 2007

NMFS conducted SONAR surveys November 9-11, 2007. The raw data produced by the SONAR equipment was processed via an algorithm calibrated to identify the substrate material. All analysis was reviewed to ensure that the algorithm identifications were correct.

Due to low tidal volume during the survey period, NMFS was not able to cover all of the target areas identified in the initial scope. The target area located northwest of Grassy Island was surveyed by MBNEP staff in winter 2008. See figure 8 of the survey track covered by NMFS single beam SONAR. A brief summary report and maps of NMFS results are presented in the appendix (Attachment C).

**Area 1:** Ground truthing efforts in this area were completed by both NMFS and the MBNEP. (See Figure 8, pg. 17) The numerous field efforts failed to identify any significant eelgrass growing in the area. The classification was changed to green algae to reflect the more dominant vegetation type in the area.

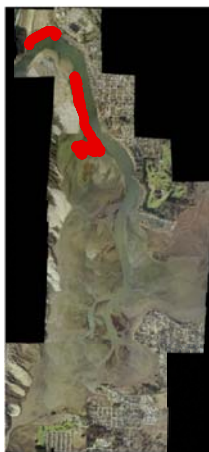
Morro Bay  
NOAA Fisheries  
Eelgrass Survey  
November 7-8, 2007

- No Eelgrass Detected
- Low Eelgrass Density
- Medium Eelgrass Density
- High Eelgrass Density

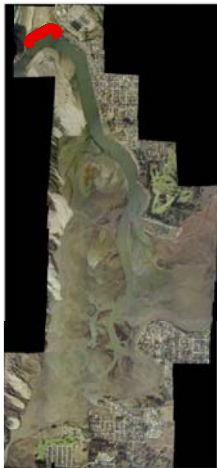
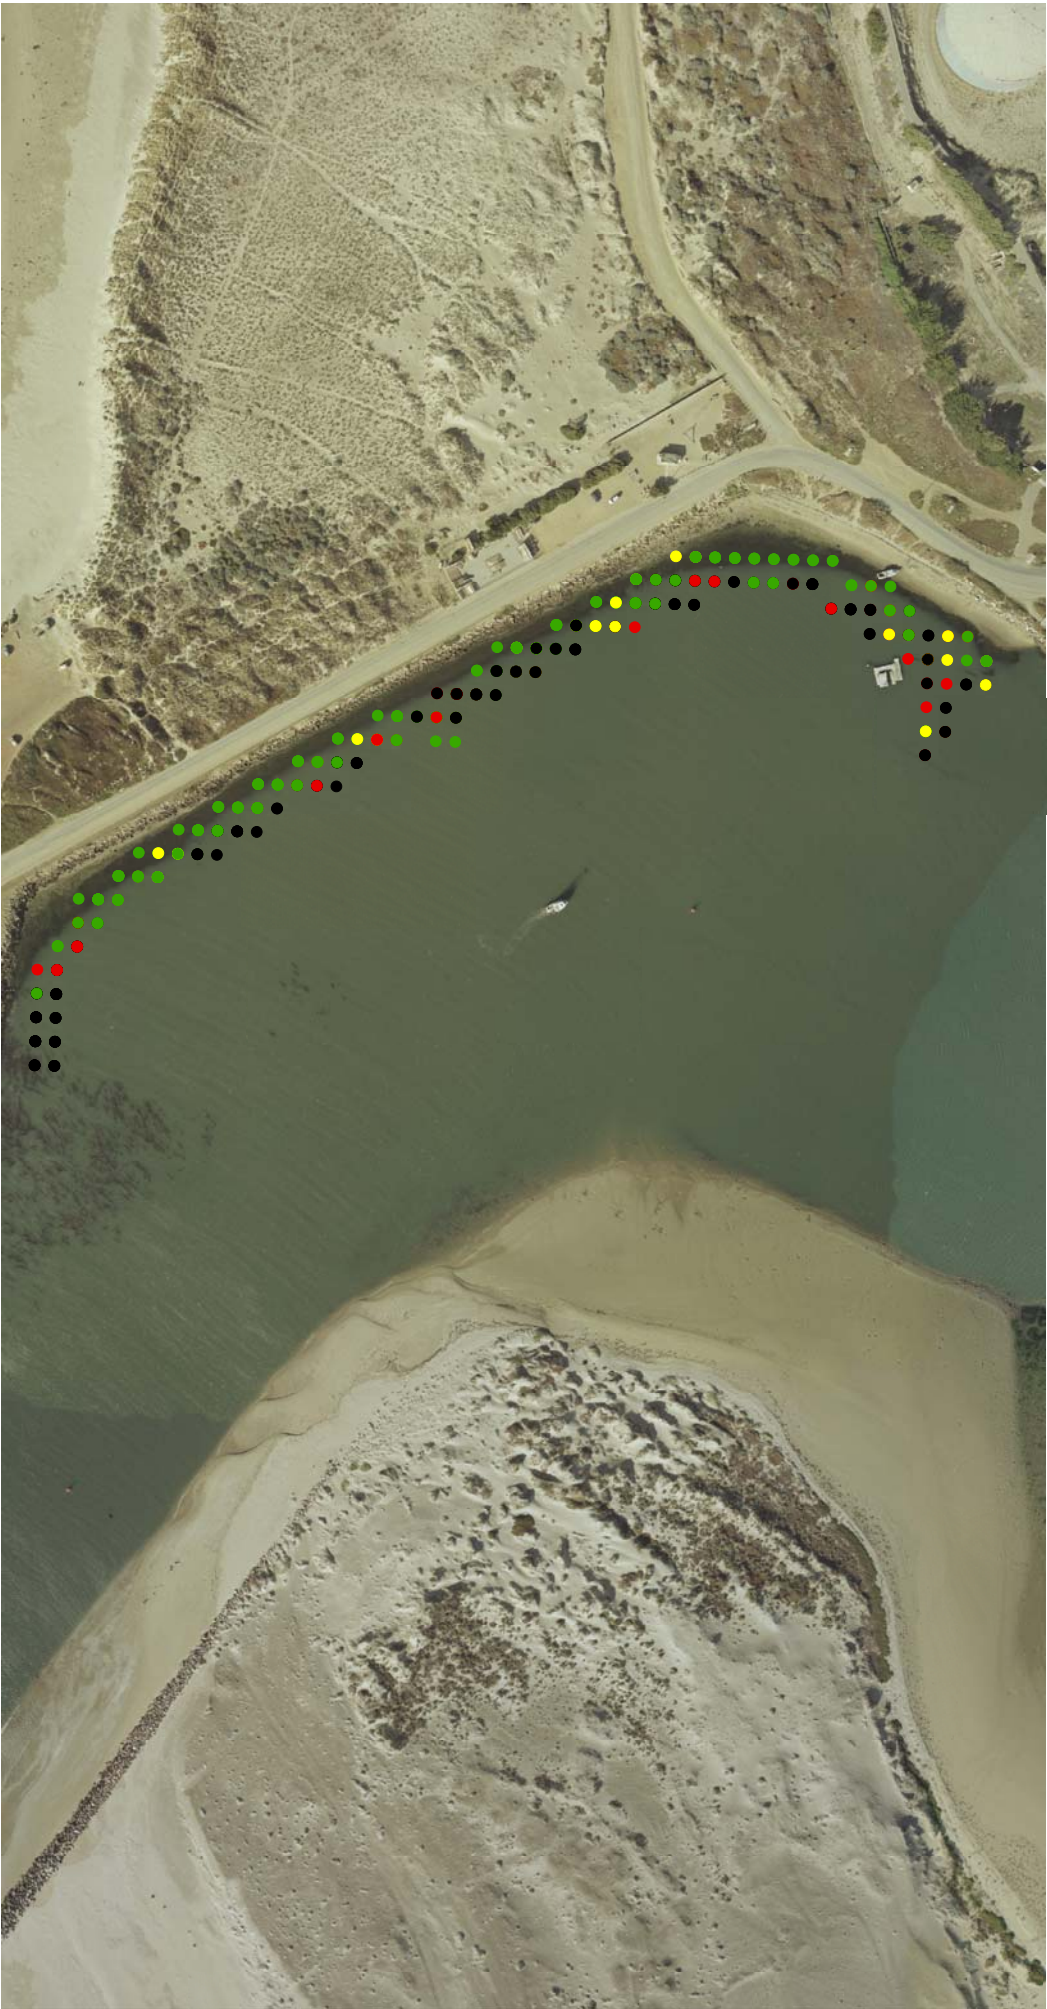
**Figure 4:**  
**Morro Bay**

Morro Bay  
NOAA Fisheries  
Eelgrass Survey  
November 7-8, 2007

- No Eelgrass Detected
- Low Eelgrass Density
- Medium Eelgrass Density
- High Eelgrass Density

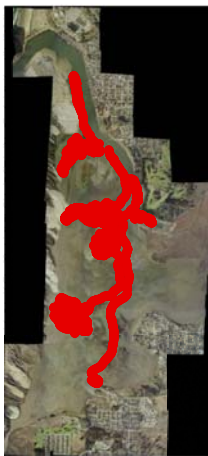
Morro Bay  
NOAA Fisheries  
Eelgrass Survey  
November 7-8, 2007

- No Eelgrass Detected
- Low Eelgrass Density
- Medium Eelgrass Density
- High Eelgrass Density

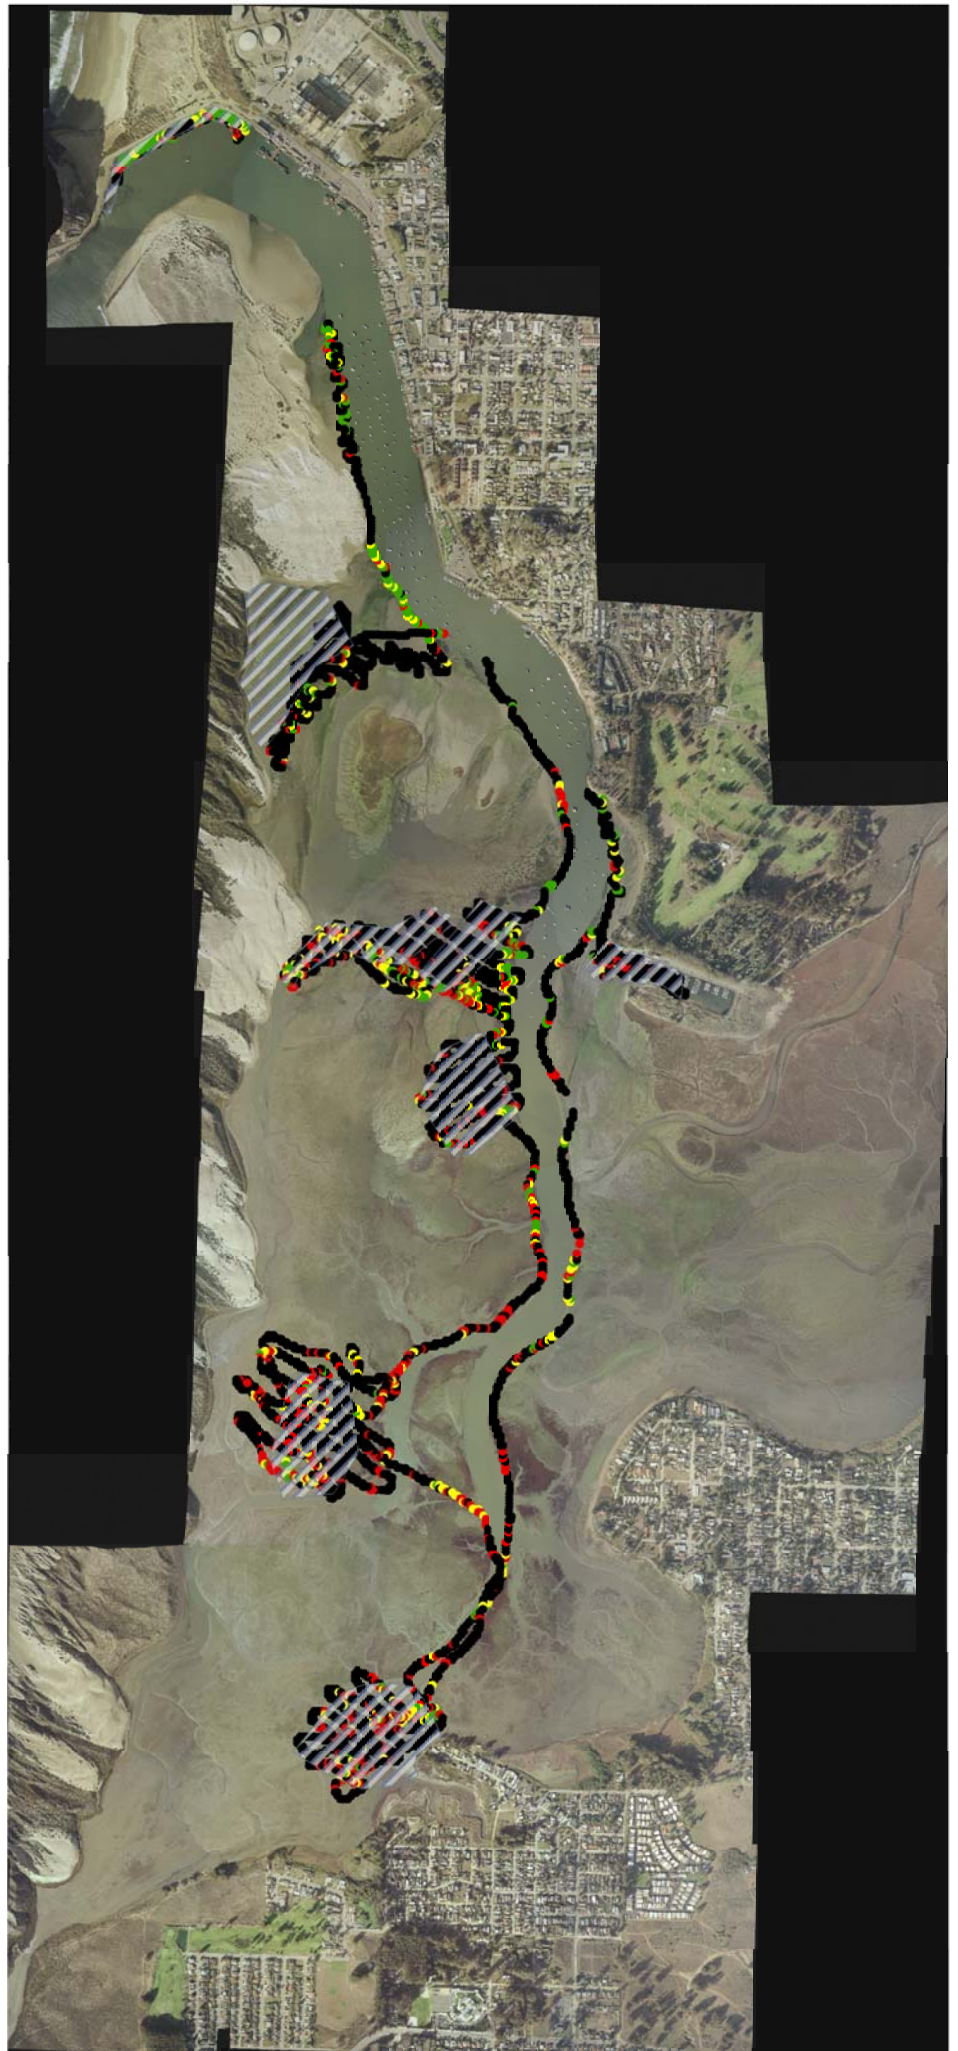
NOAA Fisheries  
Eelgrass Survey  
November 7-8, 2007

- No Eelgrass Detected
- Low Eelgrass Density
- Medium Eelgrass Density
- High Eelgrass Density
- ▨ Survey Focus Areas
